Hawk-Eye Home Inspections, LLC

Home Inspection Report

Address: 123 Sample St Beaufort, SC 29907		Date: 11/14/2012	
		Arrival: 09:00 AM	Departure: 11:00 AM
Name: Rea Quest		Inspector: Lenny Andrews	
Occupied/furnished The residence was occupied/furnished at the time of inspection. According to the states standards of practice a residential home inspection is limited to readily accessible area's. No disassembly of equipment or activating of equipment that has been shut down should be performed. No opening of walls, moving of furniture/appliances/stored items or excavation is to be performed.			
Mailing Address 987 Test Dr Bluffton, SC 29910		Agent Information Name: none Company: n/a	
Phone: (843) 555-5555		Payment Information Made By: Buyer Price: \$ 000.00 Method: Paid at the time of the inspection

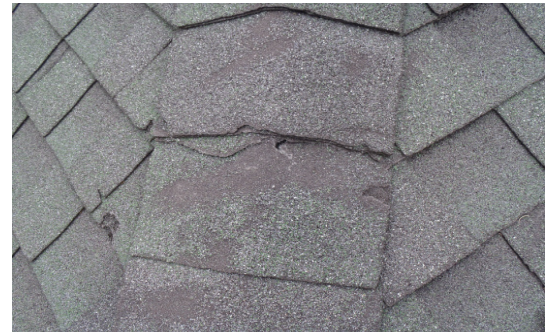
Damaged roof shingles found on the back of the home.

Minor Repair

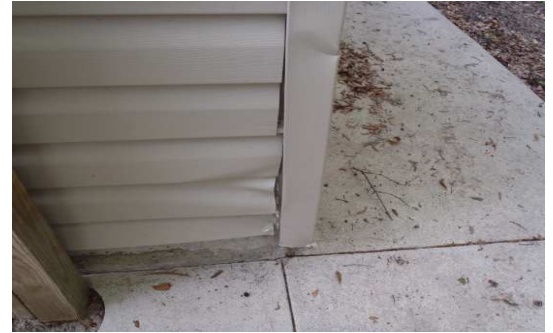
Damaged siding found on the back left corner of the home.

Cosmetic Repair

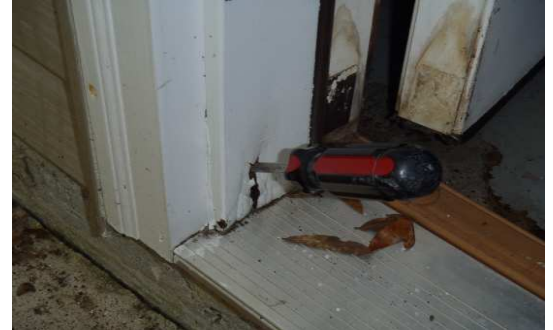
Dry rot/water damage found on the bottom of the door casing on the back of the home.

Minor Repair

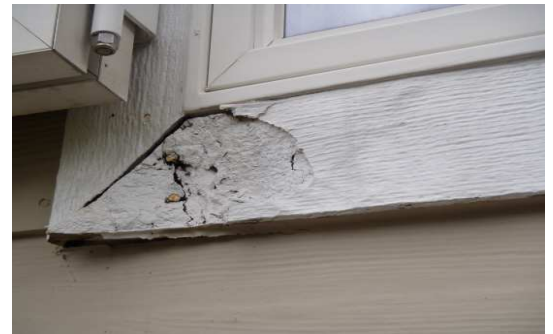
Dry rot/water damage found on the exterior window trim on the front of the home.

Minor Repair

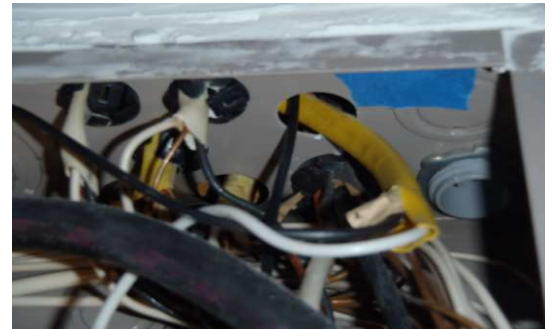
Wires improperly run from the breaker box. The outgoing wire(s) did not have wire fasteners (romex connectors) installed. Wire fasteners prevent wires from fraying against the metal panel box and possibly shorting.

Safety Concern

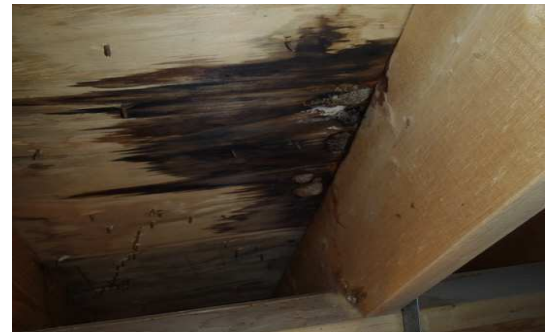
Roof leak found with high moisture reading (active leak) on the interior side of roof sheathing. Leak was found over the bedroom area. Recommend repair by a licensed roofer.

Major Concern
